Pike Lake - Curly Leaf Pondweed Project

Year 1 Report of Plant Survey Findings

for Pike Lake and the Turtle River

Pike Lake (Iron County, Wisconsin) Aquatic Invasive Species Report

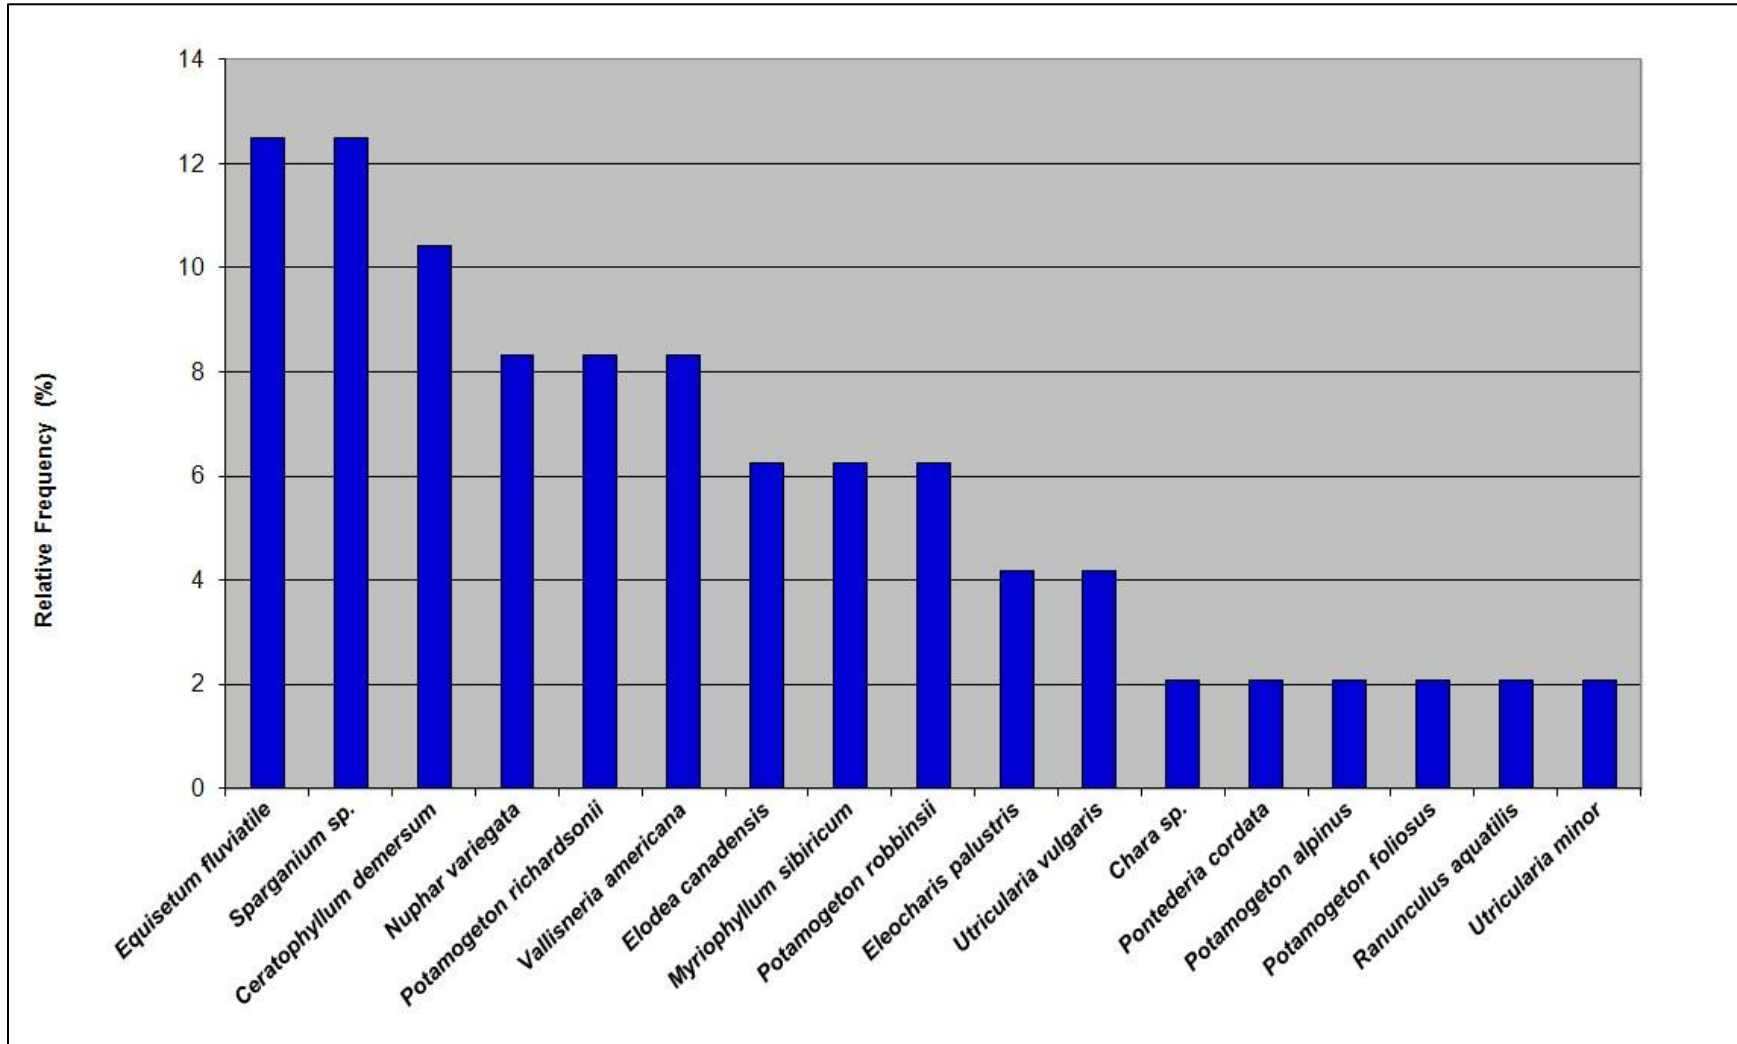
Exhibit 6. Pike Lake aquatic plant occurrences for 2020 point-intercept survey data.

Results from the point-intercept plant survey for Pike Lake are summarized and presented in Exhibits 4, 5, and 6. The maximum depth of rooted vegetation was 7.5 feet. Of the 699 sampling points on the lake, only 95 were less than or equal to this depth and twenty-eight of those points actually had rooted vegetation. The plant community is diverse with 17 species collected at the sampling points and an additional 11 species observed. The Simpson Diversity Index is high (0.92) indicating a diverse plant community. The Floristic Quality Index for Pike Lake (26.25) also indicates a good quality plant community (this value is higher than the median value for northern lakes). Exhibit 6 is a distribution of the relative frequency of plant species in the lake and this displays the pattern of frequencies typical of a healthy plant community.

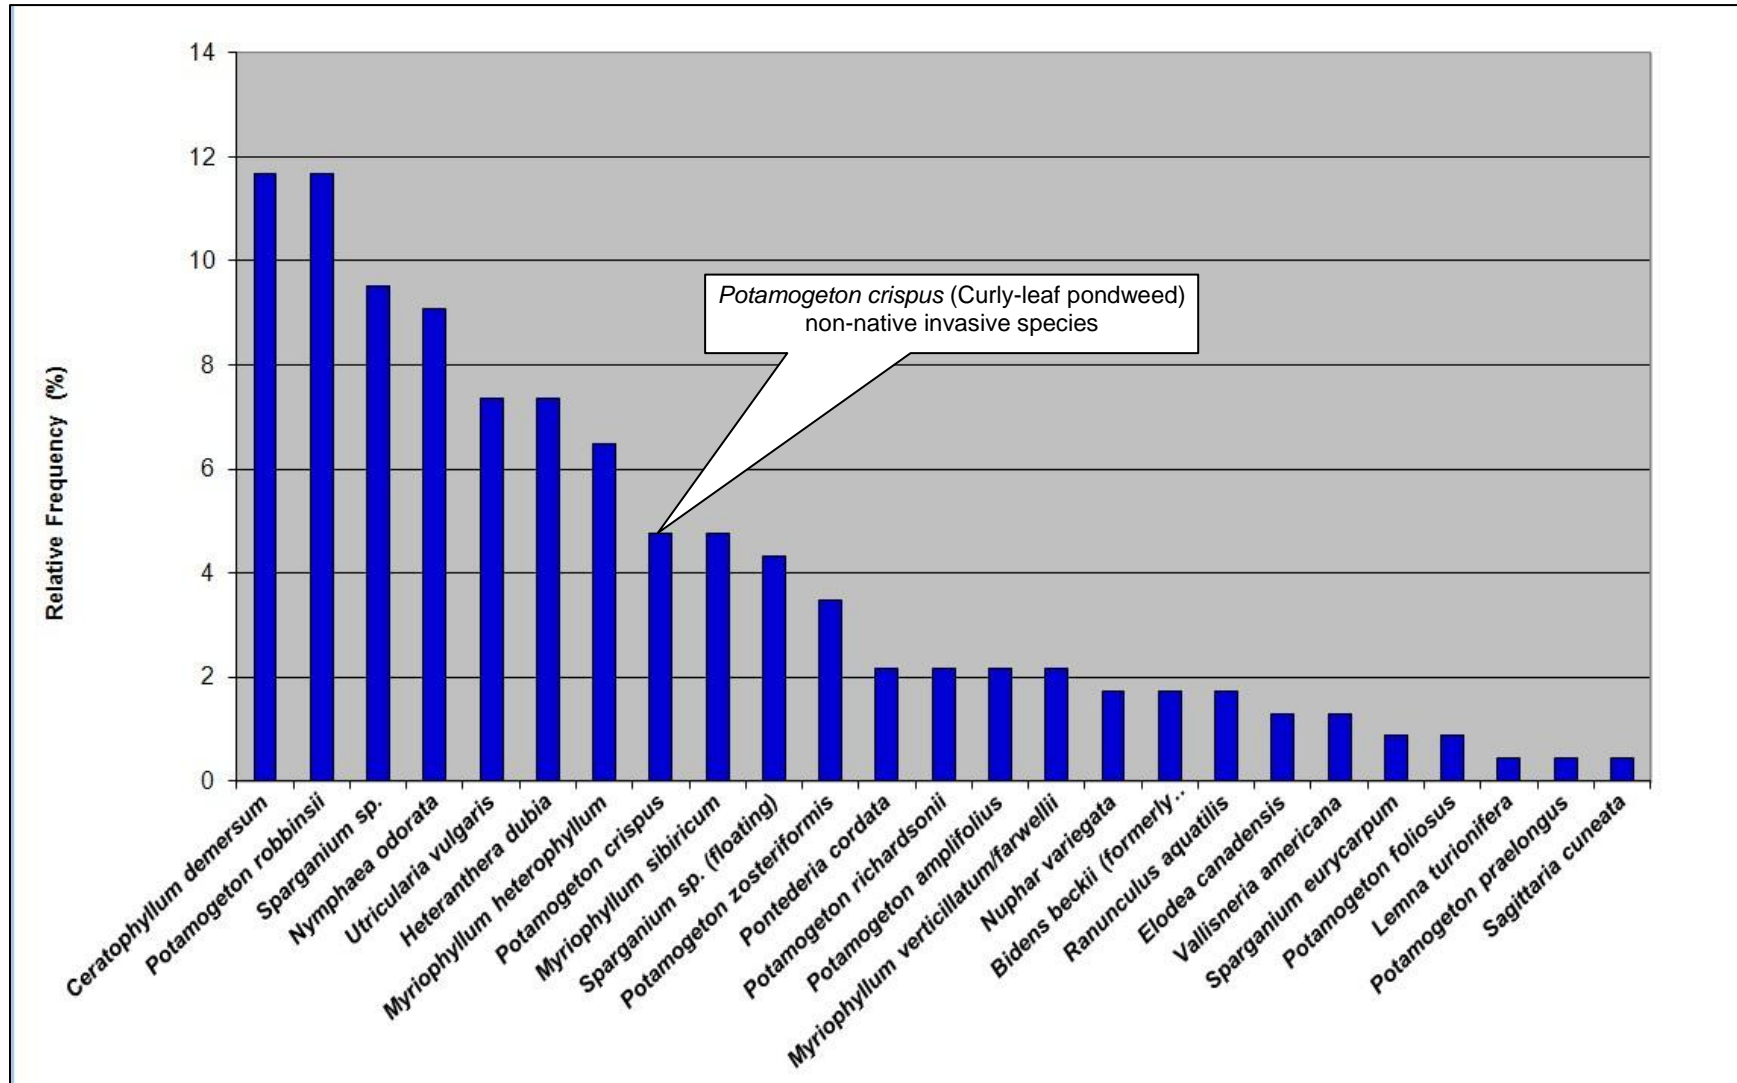
Exhibit 9. Turtle River aquatic plant occurrences for 2020 point-intercept survey data.

Results from the point-intercept plant survey for the Turtle River are summarized and presented in Exhibits 7, 8, and 9. The maximum depth of rooted vegetation was 6.0 feet. Of the 206 sampling points on the river, 176 were less than or equal to this depth and 85 of those points actually had rooted vegetation. The plant community is diverse with 25 species collected at the sampling points and an additional 14 species observed (for a total number of species at 39). The Simpson Diversity Index is high (0.93) indicating a diverse plant community. The Floristic Quality Index for this stretch of the Turtle River (28.2) also indicates a good quality plant community. Exhibit 9 is a distribution of the relative frequency of plant species in the river and this displays the pattern of frequencies typical of a healthy plant community. It should be noted that curly-leaf pondweed had a relative frequency of 4.8%. It is anticipated that this value will be reduced over time through the hand-pulling management of this AIS.

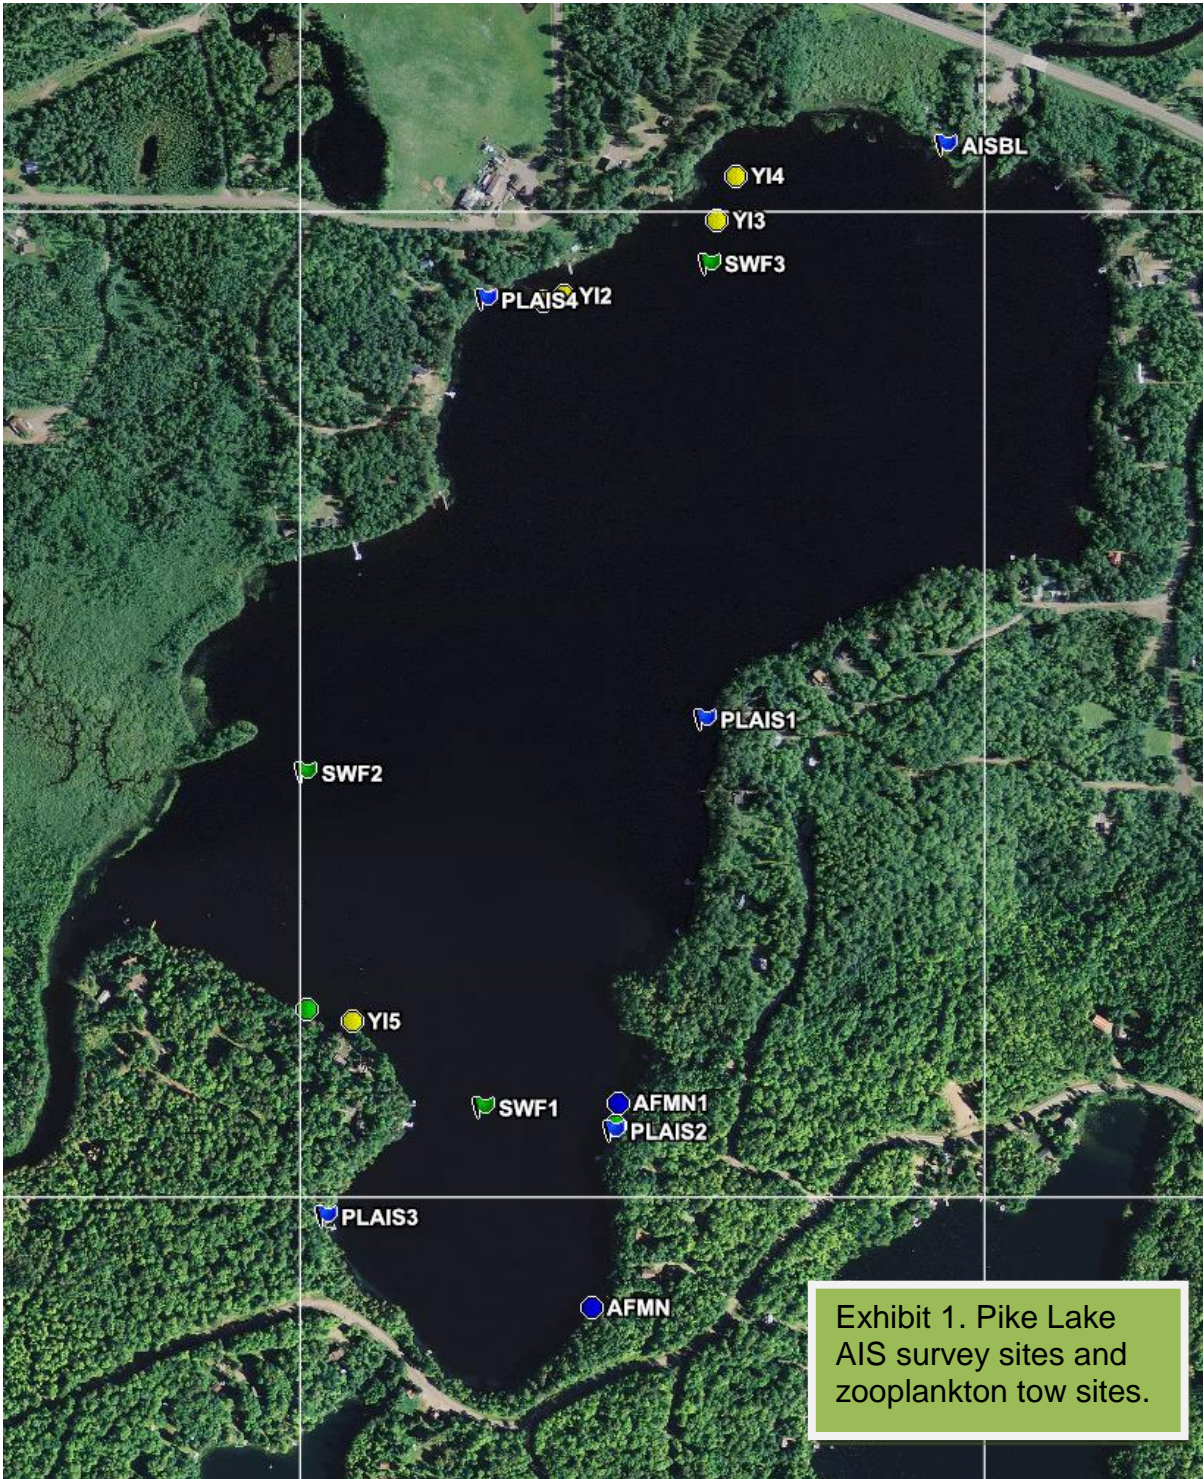
One aquatic invasive species (curly-leaf pondweed) was known to be present in Pike Lake prior to this survey. During the survey, two additional invasive plants were observed: (1) yellow iris (*Iris pseudacorus*) and (2) aquatic forget-me-not (*Myosotis scorpioides*). Site 1 had no AIS present. Sites 2 and 3 had curly-leaf pondweed. Site 4 had yellow iris present at a rating of 2. Rigger's boat landing had yellow iris. A yellow iris voucher was collected and pressed and confirmed by Dr. Freckmann (U.W. Steven's Point Herbarium) October, 2020. The yellow iris was found at seven total locations during the survey. It should be noted that we collected reed canary grass from the Turtle River immediately upstream for Pike Lake (confirmed by Dr. Freckmann). Because of this upstream source, this species should be monitored for its occurrence on Pike Lake. A meander search was conducted in between sites on Pike Lake. Exhibit 1 displays locations of sightings for yellow iris (YI), curly-leaf pondweed (PLCLP), and aquatic forget-me-not (AFMN).

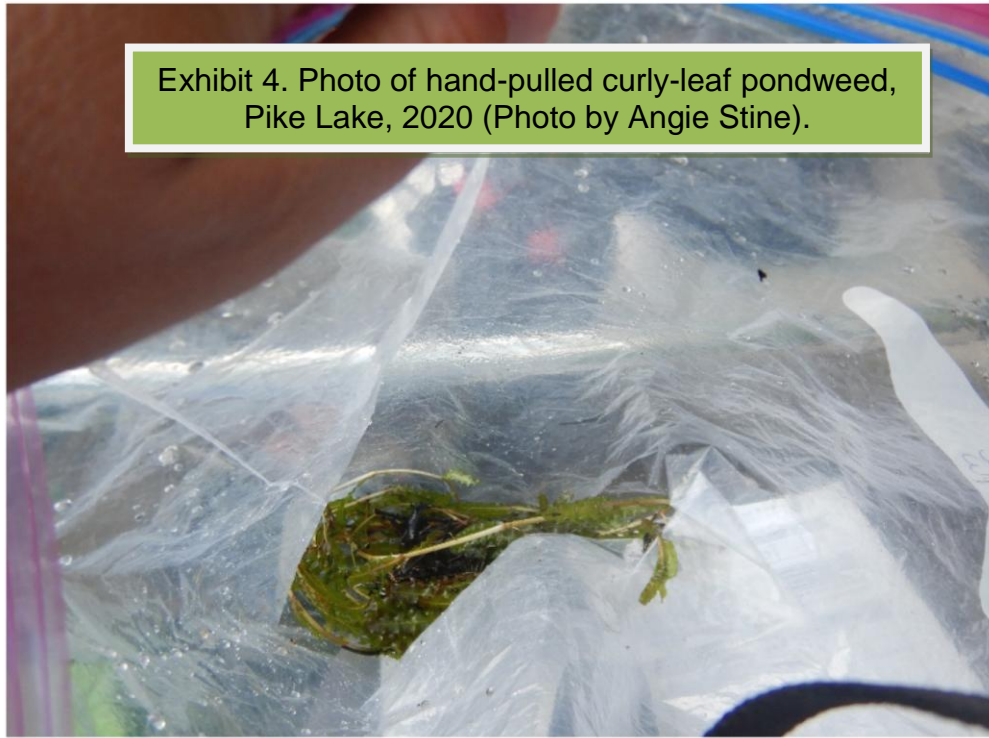
Curly-leaved pondweed (*Potamogeton crispus*) is an invasive aquatic perennial that is native to Eurasia, Africa, and Australia. It was accidentally introduced to the US waters in the mid-1880s by hobbyists who used it as an aquarium plant. The leaves are all submersed and alternate with no leaf stalks; oblong, still, translucent leaves (4-10 cm long, 5-10 mm wide) have distinctly wavy edges with fine teeth and 3 main veins (WDNR, 2021) The plant usually drops to the lake bottom by early July. Exhibit 4 is a sample of curly-leaf pondweed that was pulled from Pike Lake.

Exhibit 4. Photo of hand-pulled curly-leaf pondweed, Pike Lake, 2020 (Photo by Angie Stine).

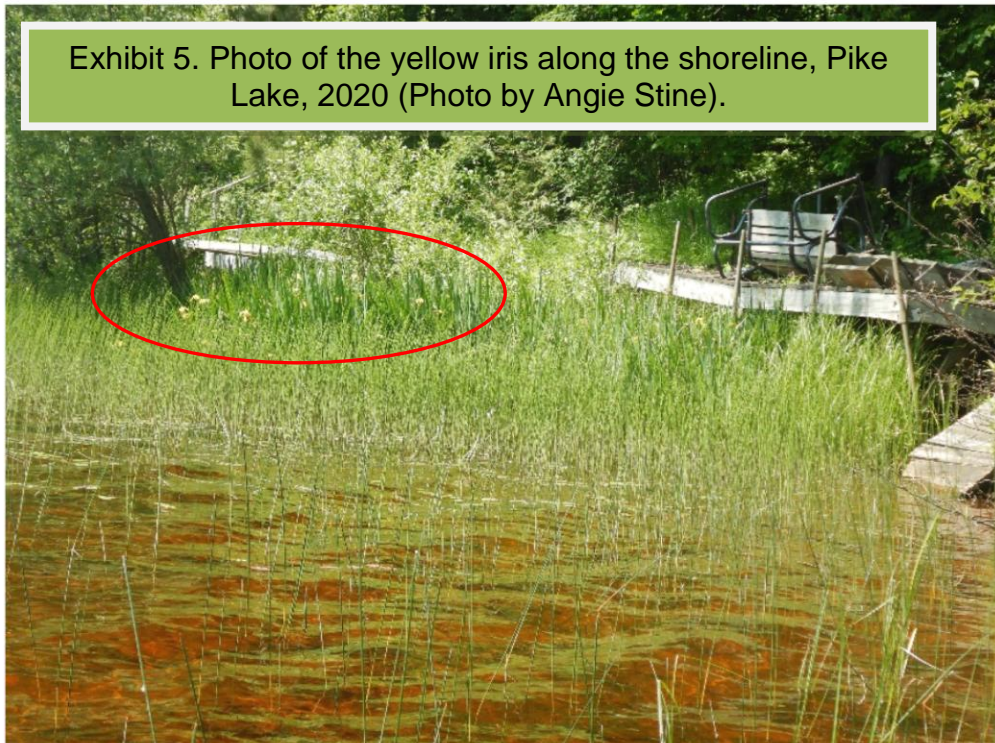
The yellow iris (*Iris pseudacoris*) is a perennial aquatic plant native to Europe, western Asia and North Africa. It was first introduced to North America in the 1800s as an ornamental plant. Over time, the plant has spread too many wetlands and proliferated to the detriment of native plants and animals. Yellow iris is present on numerous Wisconsin lake margins and the Wisconsin Department of Natural Resources has listed this species as “Restricted” which prevents its sale, transfer, transportation and intentional cultivation. Yellow iris can reduce habitat needed by fish and waterfowl (Thomas, 1980). A yellow iris was located along the shoreline at Pike Lake (Exhibit 5).

Exhibit 5. Photo of the yellow iris along the shoreline, Pike Lake, 2020 (Photo by Angie Stine).

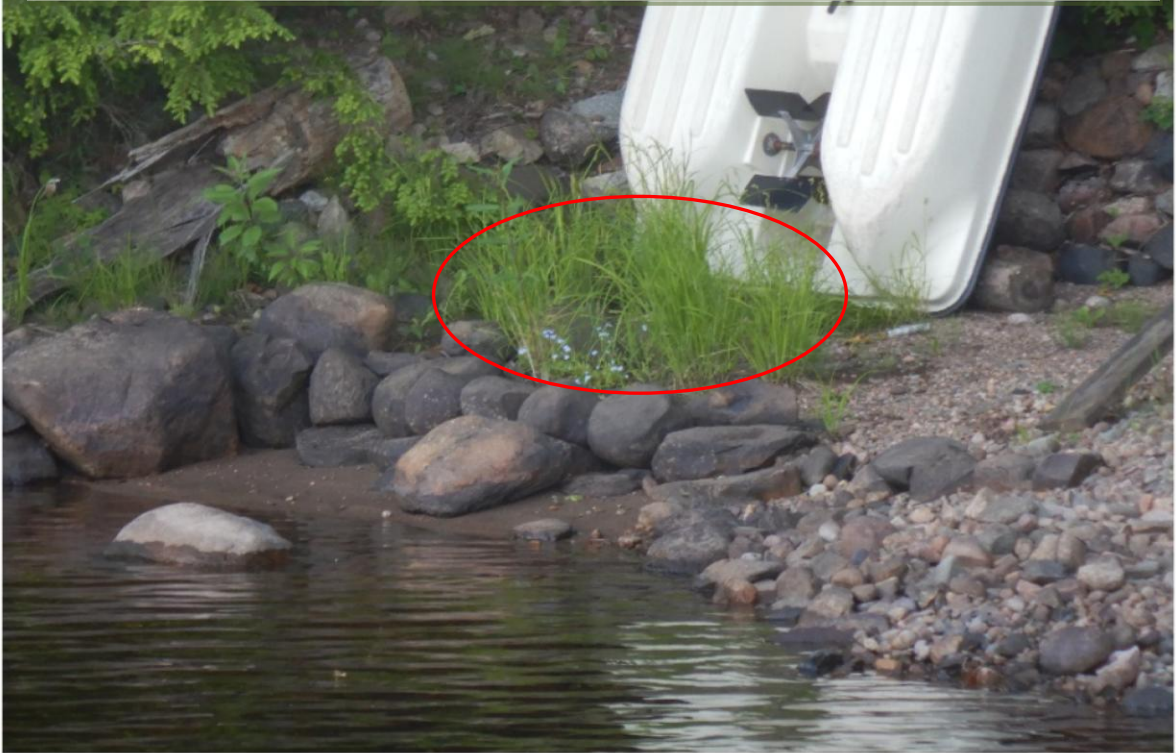
Aquatic forget-me-not (*Myosotis scorpioides*) quickly crowd out native plant species and is able to form large monocultures, especially in situations where it is in or near a stream (WDNR, 2019). This plant is restricted in Wisconsin. The aquatic forget-me-not was found at two locations on Pike Lake. A sample was not collected but a photo was captured at one location (Exhibit 6).

Exhibit 6. Photo of the aquatic forget-me-not along the shoreline, Pike Lake, 2020 (Photo by Angie Stine).
